Hollicombe Bay

The problem.

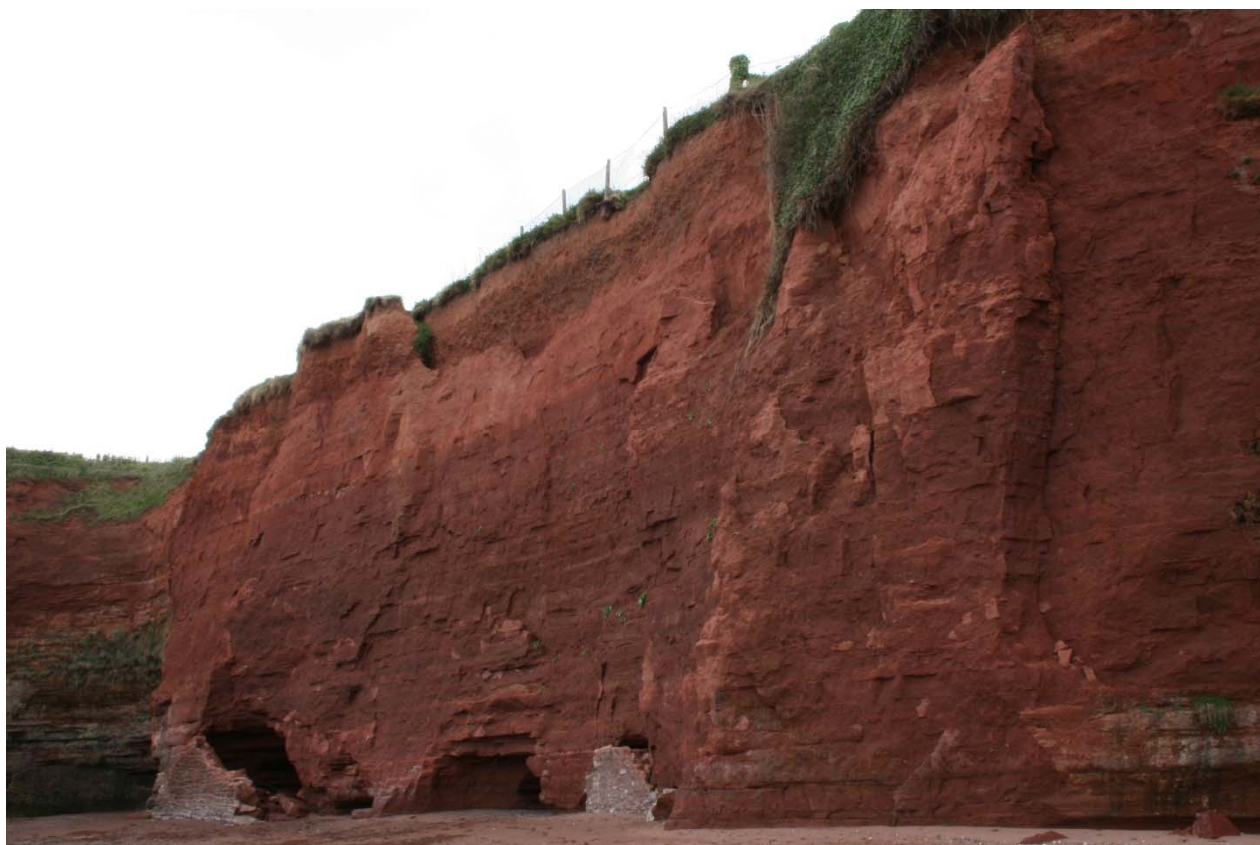
Hollicombe Bay is a popular Torbay beach backed by attractive red sandstone cliffs. The stability of these soft cliffs is constantly undermined by the sea forming and enlarging beach level caves. In the past the caves have been sealed with masonry walls which have deteriorated in recent times. In 2008 the beach was closed due to a number of significant rock falls. To complicate matters, the base of the cliff is tidal.

Hollicombe bay cliffs prior to remedial works

- Remove 400m³ of unstable sandstone pillars from the cliff.
- Install rock netting to control further erosion and protect the VT work force.
- Excavate the caves down to a foundation level.
- Build concrete filled sandbag bunds at the cave openings.
- Fill the caves with pumped concrete contained by the bunds.

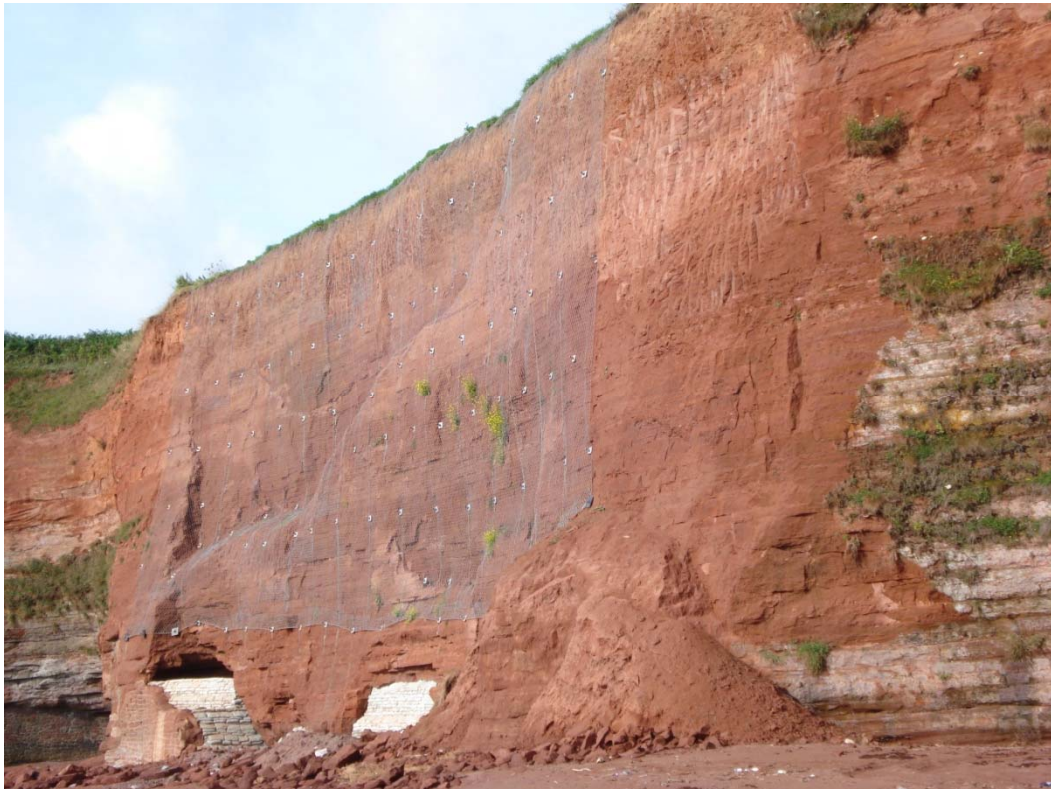
The rock face scaled, netted and bunds part built

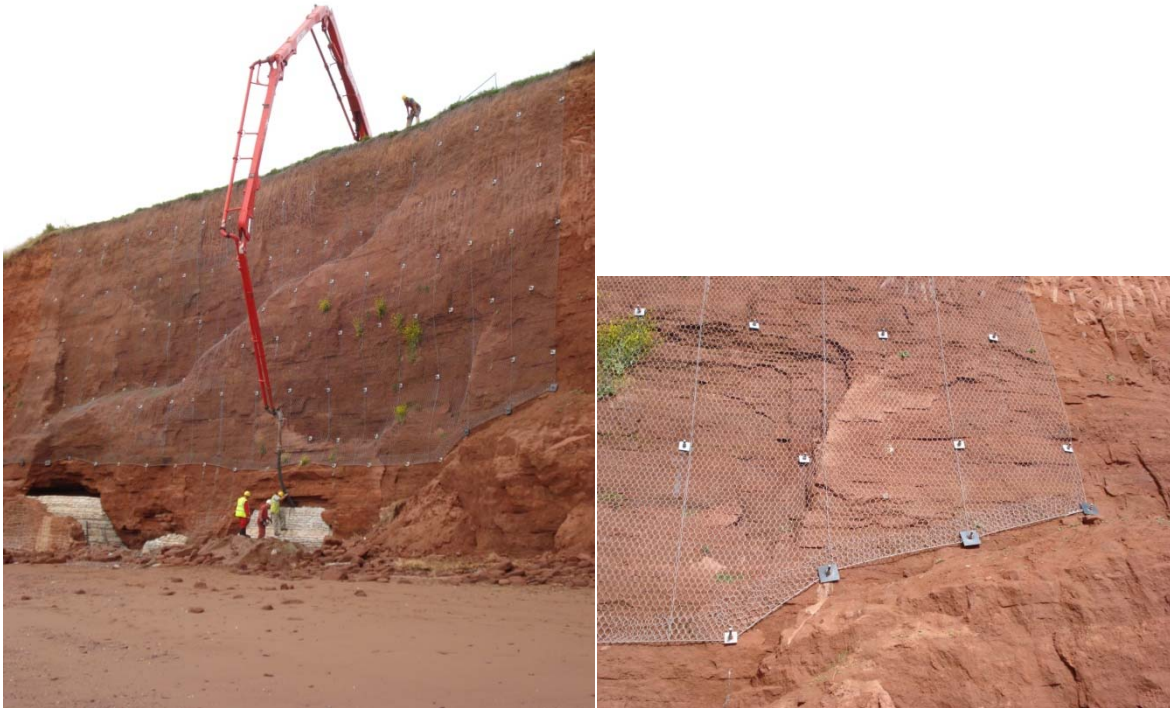
Pumping concrete into caves and Rock netting detail
